December 21, 1962
DMIC Memorandum 161

ELECTRON MICROSCOPIC FRACTOGRAPHY

DEFENSE METALS INFORMATION CENTER
BATTELLE MEMORIAL INSTITUTE
COLUMBUS 1, OHIO

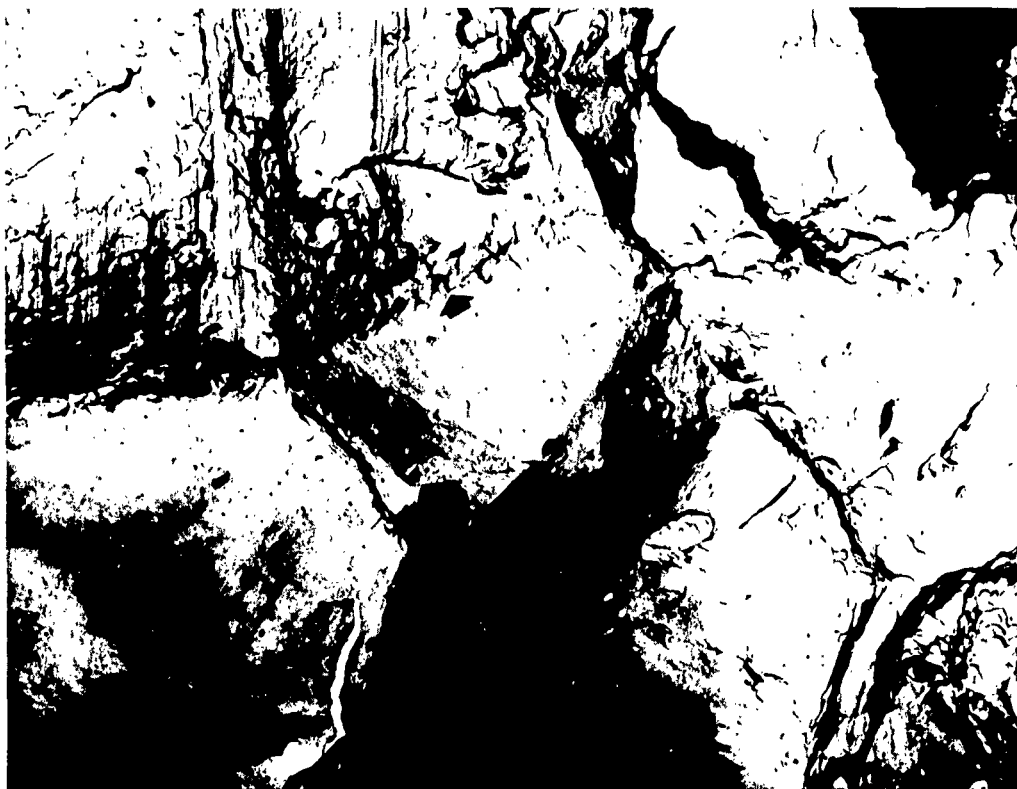
6,200X

FIGURE 3. "GLIDE-PLANE DECOHESION STRIATIONS" TAKEN TO INDICATE A DUCTILE REGION IN AN OTHERWISE BRITTLE INTERGRANULAR FRACTURE(9)

Another common feature, which is sometimes claimed to be significant, but which may be an artifact, are the striations observed in ductile fractures which are taken as being evidence of glide-plane decohesion. Glide-plane decohesion is a term which was coined by Crussard and his co-workers at IRSID⁽⁸⁾ to describe those areas on a ductile fracture which do not have the typical dimpled appearance. Figure 2 is an electron microfractograph from their paper which was made from a direct carbon replica of a ductile fracture in mild steel. Figure 3 is a fractograph showing striations in a brittle, intergranular fracture.⁽⁹⁾ These striations are taken as evidence of a region of ductile fracture by decohesion on a glide plane where slip has occurred.⁽⁴⁾ However, other investigators claim that these striations are not the result of glide-plane decohesions as described by Crussard, but are an artifact produced when the replica is scraped across a ledge on the fracture surface during stripping and that they can be avoided by more careful stripping or by the use of direct carbon replicas. A similar possible source of the striations is the dragging of the two faces of the fracture across one another in the course of separation.

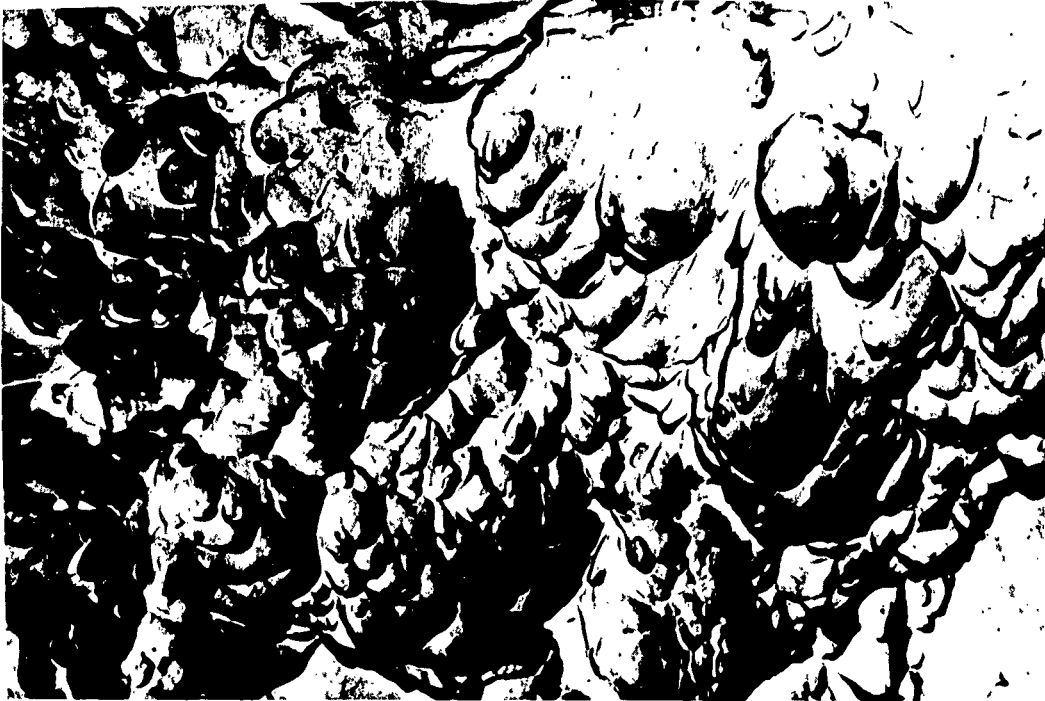
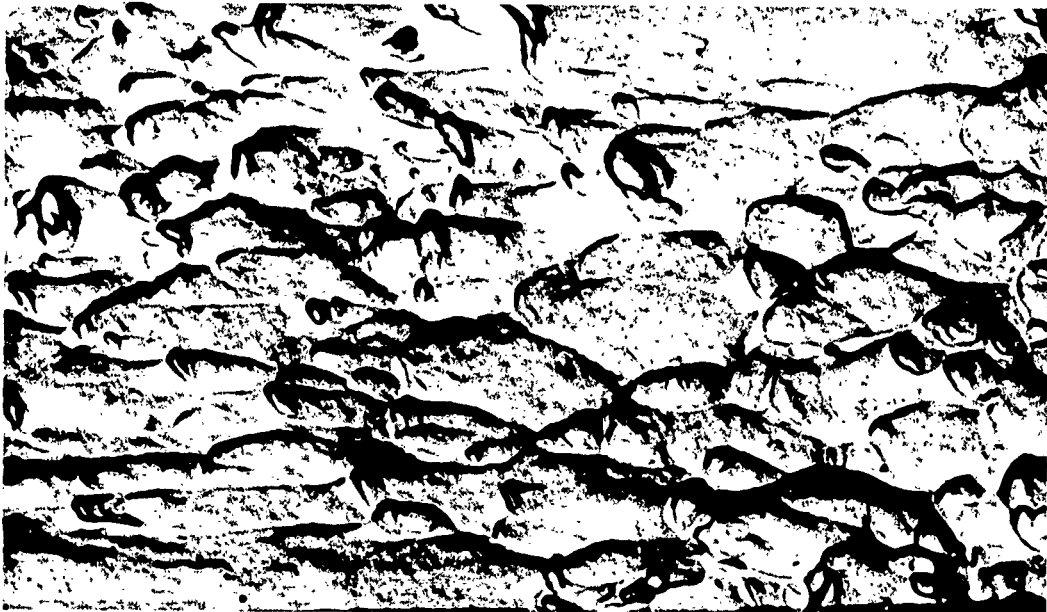
Figure 5 is a comparison of tensile and shear fractures in AISI 4340 steel(5,9). It will be noted that in the tensile fracture, the dimples are slightly elongated in random directions. This type of appearance is found in the flat transverse portion of tensile fractures. On the other hand, the dimples on the shear fracture are highly elongated in the direction of relative motion of the two fracture faces. This type of appearance is found in shear failures and in the shear-lip portion of tensile failures. It was thought at one time(5) that the direction of elongation of the ductile dimples could be used to ascertain the direction of crack propagation. It is now generally agreed that this is not so, but rather when shearing has occurred, the dimples point in opposite directions on opposite faces, as mentioned above, and when tearing has occurred the dimples point in the same direction on both faces. Another feature of the shear fracture is the appearance of a greater amount of "glide-plane decohesion".(8) Glide-plane decohesion is evidenced by relatively flat featureless areas on ductile fractures and is thought to occur by separation along planes that have been weakened by slip.

a. Tensile Fracture⁽⁹⁾

b. Shear Fracture⁽⁵⁾

FIGURE 5. TENSILE AND SHEAR FRACTURES IN AISI 4340 STEEL, 260 to 280 KSI

As was pointed out above, each void which appears as a dimple on the fracture surface, is nucleated at an inclusion. In Figures 4 and 5, many inclusions can be seen associated with the dimples. The relative size of the dimples is related directly to the size, nature, and distribution of the inclusions and precipitates in the material and is independent of the strength, composition or other material or loading variables. A fine, dispersed precipitate will produce small dimples and coarse precipitates will produce large dimples, so the dimple-size distribution will reflect the precipitate-size distribution. In fact, a material with particles of two distinct sizes (i.e., undissolved intermetallic compounds and small reprecipitated particles) will show a duplex dimple size. Using this theory of ductile fracture (void nucleation by precipitates) it is possible to derive a mathematical expression relating the total strain to fracture to the volume per cent of inclusions which gives good agreement with experiment.(14) So, the total strain to fracture is a function of the total amount of inclusions while the dimple size is a function of the size and distribution of the inclusions.

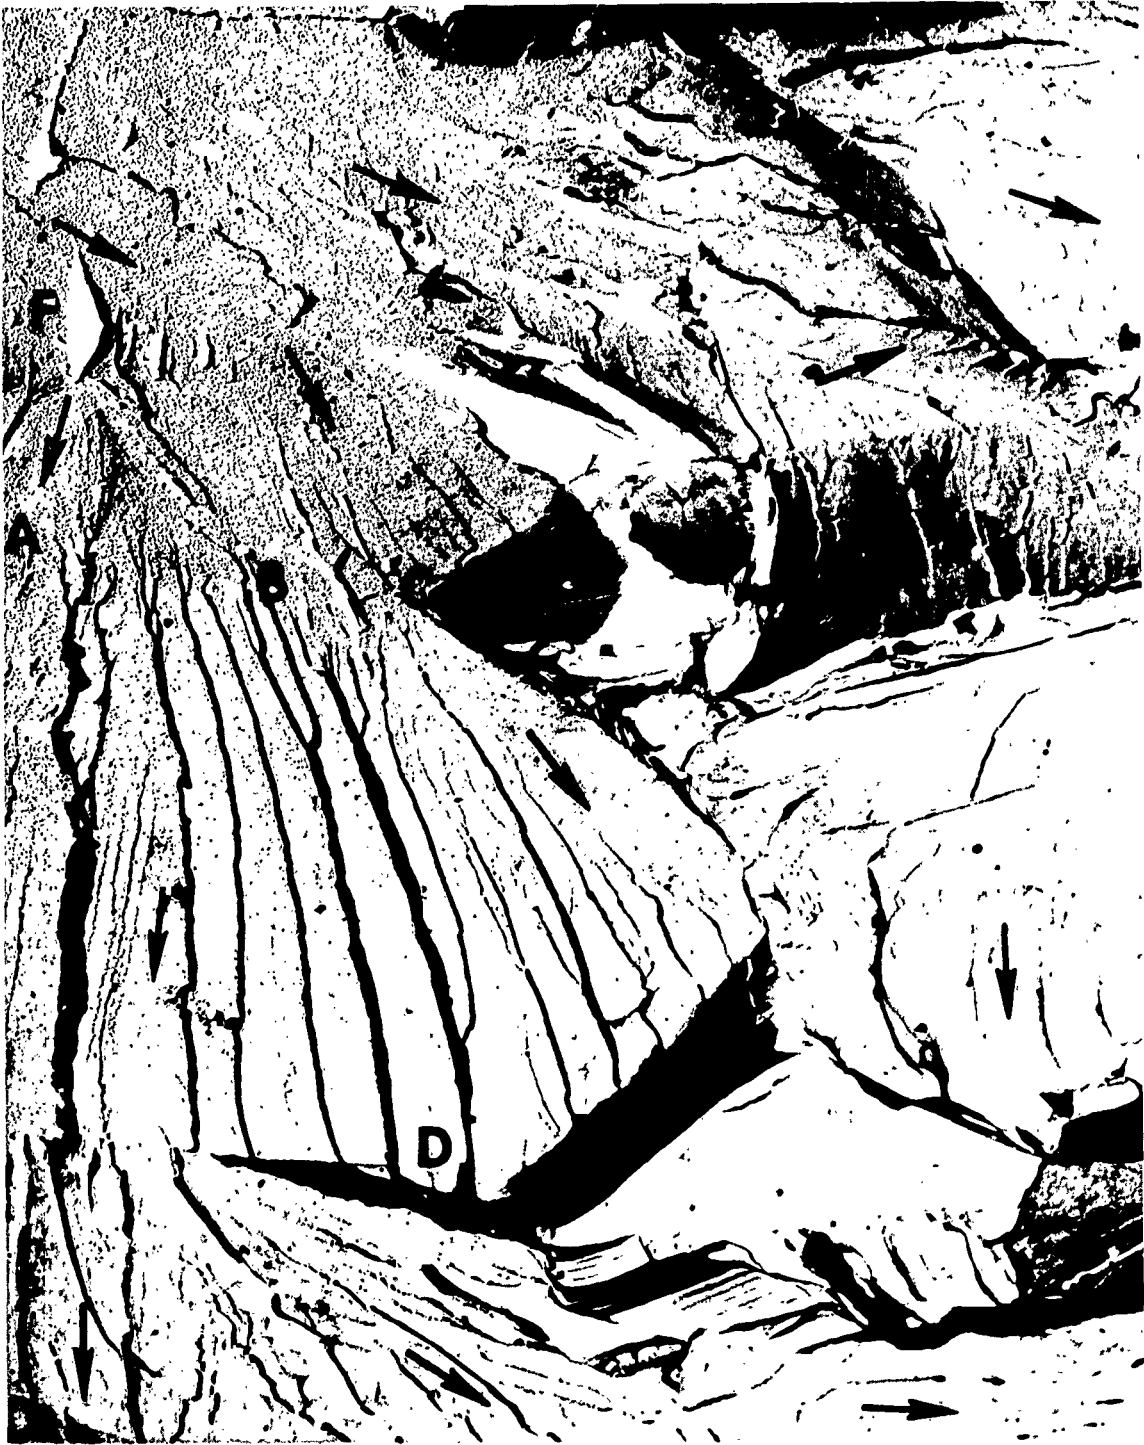
6,000X

FIGURE 6. CLEAVAGE FRACTURE IN IRON BROKEN AT 78 K⁽¹³⁾

- (a) Change in orientation of the cleavage plane in crossing grain boundaries (D)
- (b) Indications of the local direction of crack propagation by the river markings on the cleavage facets (arrows)
- (c) Variability of the direction of crack propagation from grain to grain
- (d) Formation of small cleavage "tongues" which are due to the cleavage of deformation twins formed by plastic deformation at the tip of the propagating crack (F).

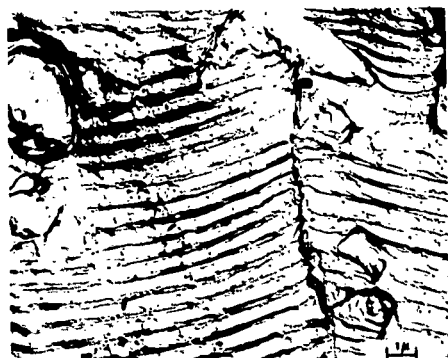
a. 7178 Aluminum Alloy (13)

b. Mild Steel (8)

d. 4340 Steel, 260 to 280 ksi (9)
13,700X

c. 18-8 Stainless Steel (8)

FIGURE 7. FATIGUE FRACTURES IN VARIOUS MATERIALS

Fatigue fractures are characterized by the appearance of striations normal to the direction of crack propagation on the fracture surface. It has been shown, by the use of programed fatigue-stress cycles, that each stress cycle produces one striation on the fracture surface.^(20,21,22,23) This hypothesis has been further substantiated by comparisons of macroscopic crack growth rates with the microscopic striation spacing^(21,23,24). Typical fatigue fractures in a variety of materials are shown in Figure 7^(8,9,13). Here again, the same general appearance is obtained in essentially all alloy systems. However, as can be seen and as will be discussed in greater detail later, strength level has a profound effect on the appearance of fatigue fractures under the electron microscope.

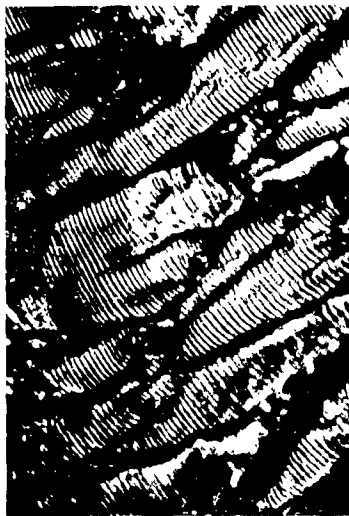
The workers at the Royal Aircraft Establishment have observed two types of striations on fatigue fractures in aluminum alloys, which they have termed ductile and brittle(15,27,28). The ductile fatigue fractures (Figure 8a)(27) are the more normal type in which striations having about the same amount of ductile and brittle fracture appear on lozenge-shaped facets. The brittle fatigue fractures appear as striations superimposed on fan-shaped cleavage facets (Figure 8b)(27). The striations on a so called brittle fatigue fracture are wider spaced and more brittle, appearing with cleavage rivers between the striation marks as well as superimposed on them. Ryder also found differences in the appearance of cross sections through the two types of fracture. The ductile-type fatigue fractures had a wavelike appearance with peaks opposite valleys on opposite faces. The striations on the brittle-type fractures appeared to be caused by small cracks off the main crack; they were opposite each other on the two faces of the fracture. Factors which favor brittle-type striations in aluminum alloys are low frequency and corrosive environment at intermediate stress levels. In Armco iron, the presence of hydrogen produced brittle striations in a fatigue fracture.

a. Ductile Fatigue Striations

b. Brittle Fatigue Striations

FIGURE 8. A COMPARISON OF DUCTILE AND BRITTLE FATIGUE STRIATIONS
IN AN Al-7.5Zn-2.5Mg ALLOY LIGHT FRACTOGRAPHS(27)

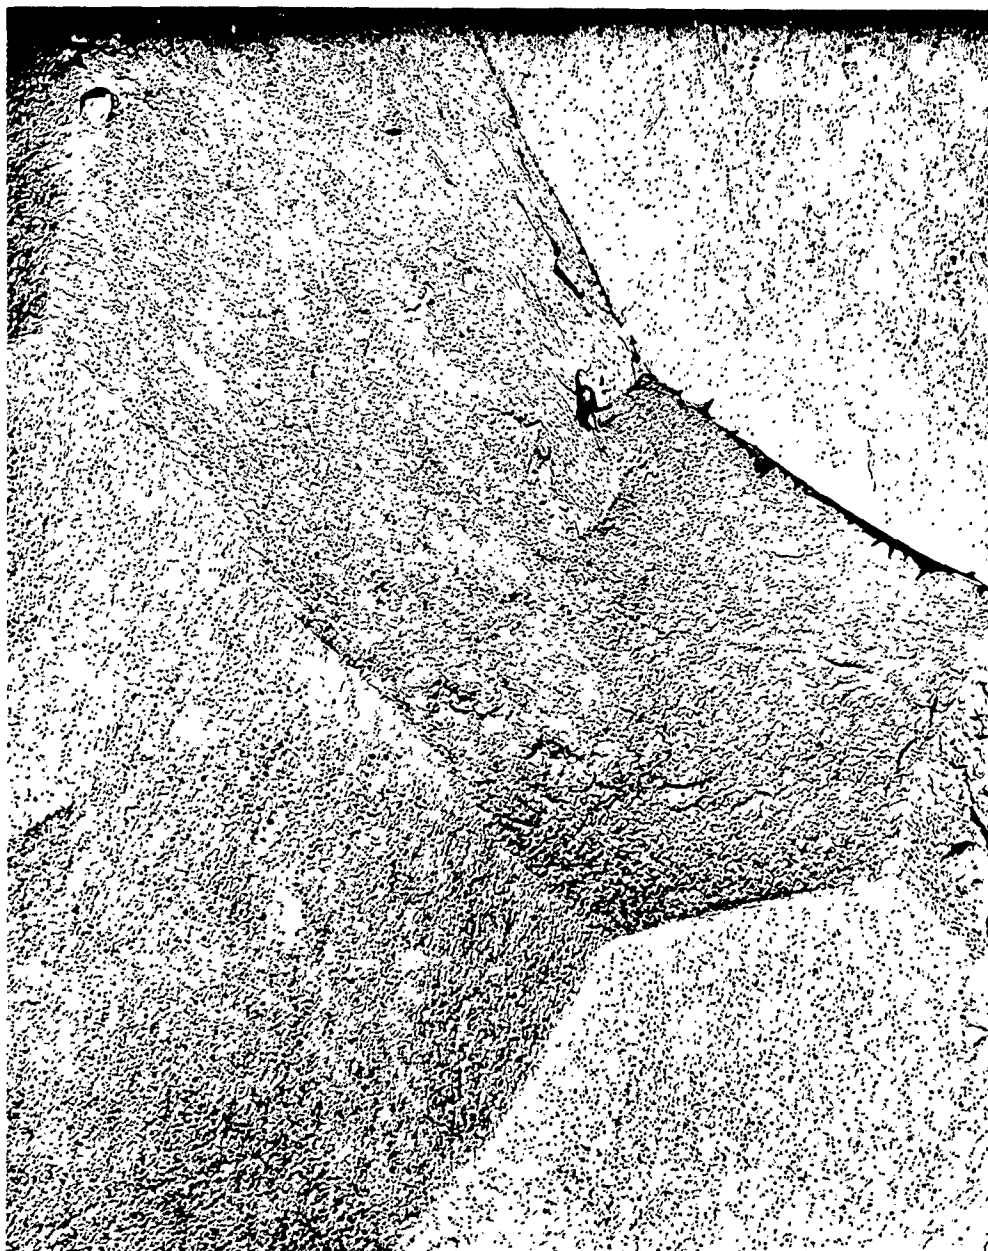
7,500X, reduced by 25%

Figures 9, 10, and 11 are fractographs of a hydrogen-induced brittle fracture, a stress-corrosion crack, and a quench crack, respectively.(13) The marked similarity among the three figures is immediately apparent. All three are definitely intergranular with no visible signs of ductility. A specimen which had been cadmium plated and stressed at a temperature above the melting point of cadmium also showed a similar fracture appearance.(9) The investigators working in the field of electron microfractography generally agree that they cannot distinguish among these types of fracture with any degree of certainty(5,9,13,16,29). However, they are optimistic that some distinguishing features will be found. Perhaps analysis of the "hairlines" which appear on the grain-boundary surfaces will provide such a key. On the other hand, the similarity in fracture appearance may indicate a similarity

FIGURE 9. HYDROGEN-INDUCED BRITTLE FRACTURE IN AISI 4340 STEEL, ULTIMATE TENSILE STRENGTH, 265 KSI; APPLIED STRESS, 30 KSI; CATHODIC CHARGED

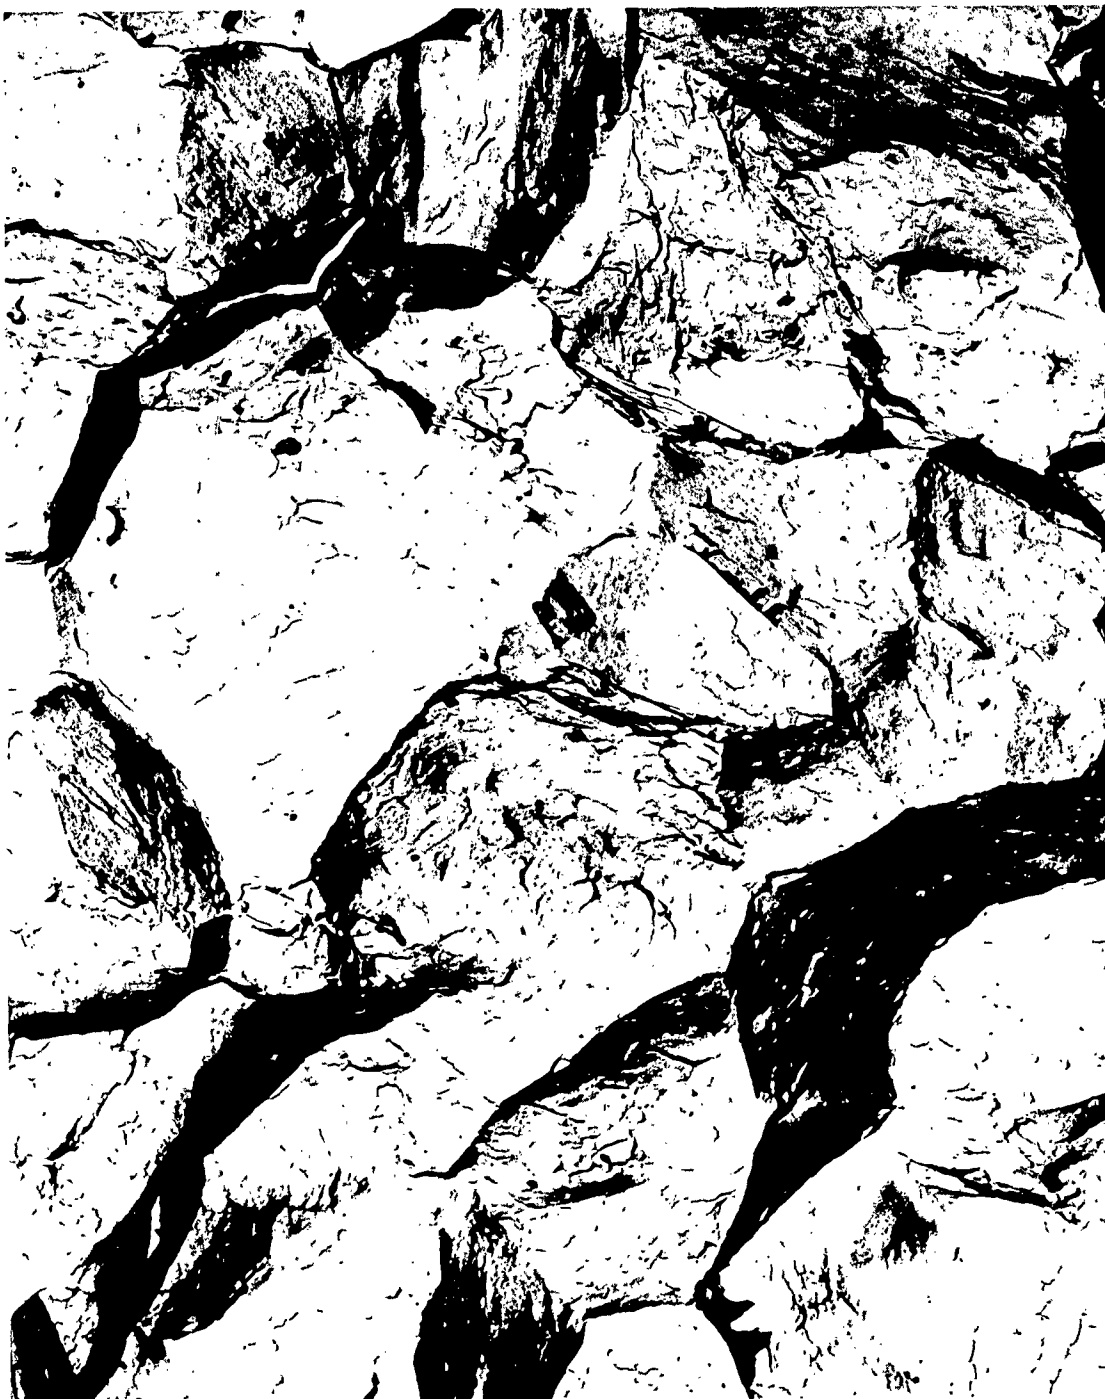
5,000X

FIGURE 10. STRESS-CORROSION CRACK IN AISI 4340 STEEL(13)

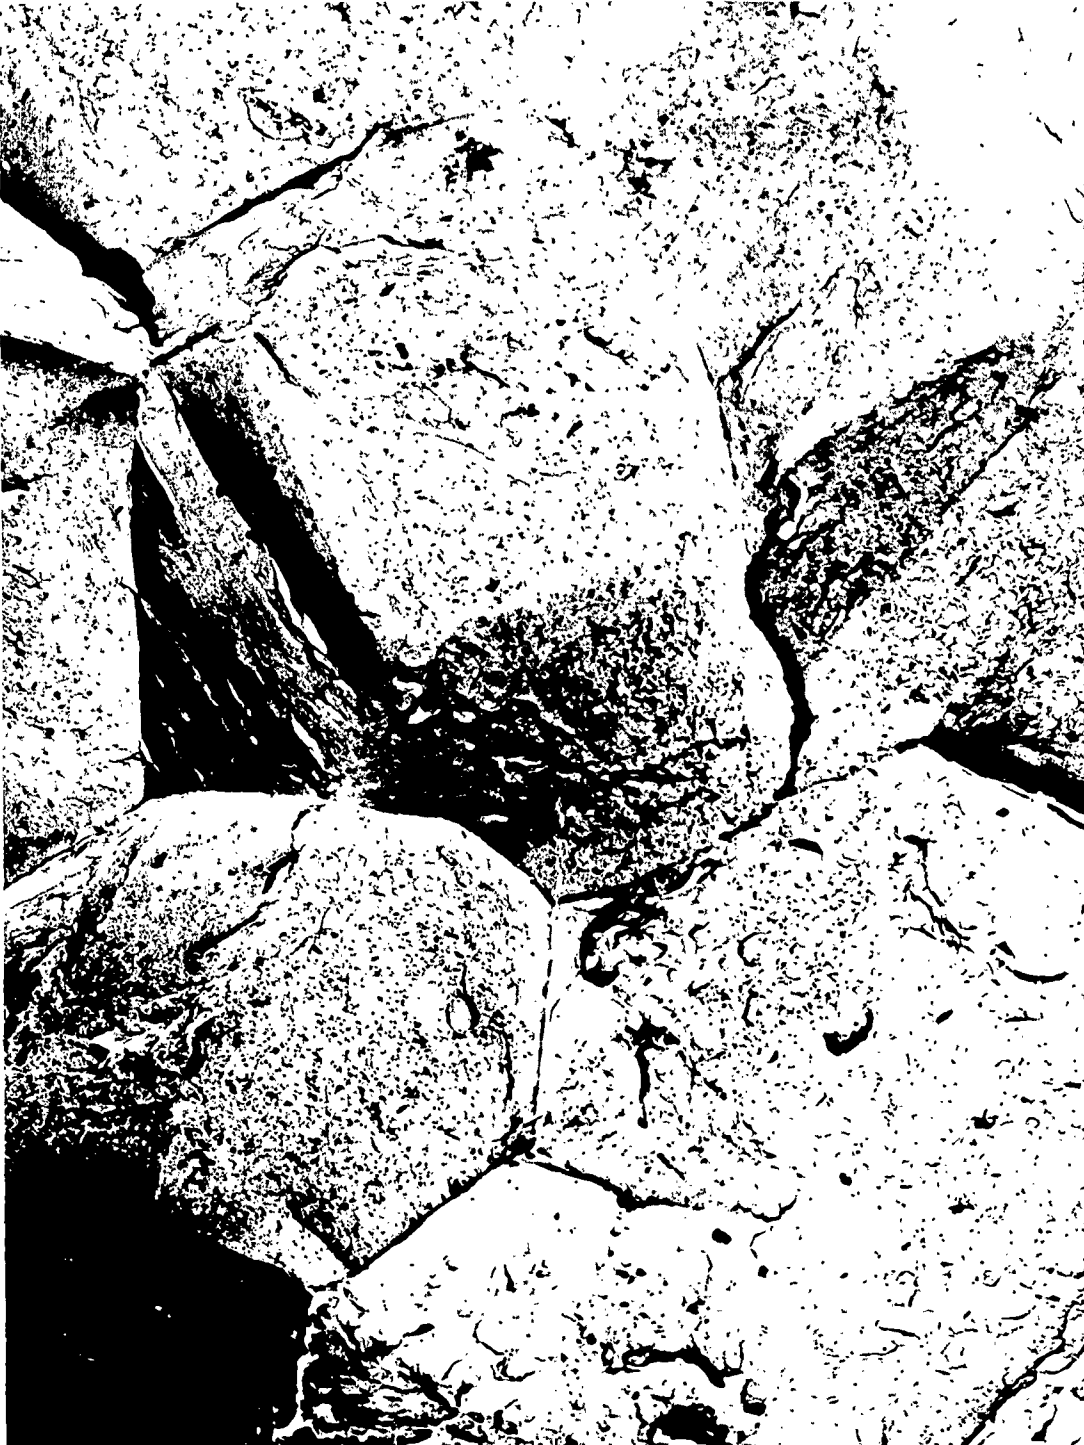
FIGURE 11. A QUENCH CRACK IN AN AISI 4340 STEEL PART⁽¹³⁾
